# Manhole Inspection Summary

Manhole # S19EE2006MH

**Location** Address: **1501 NEWBURY ST**

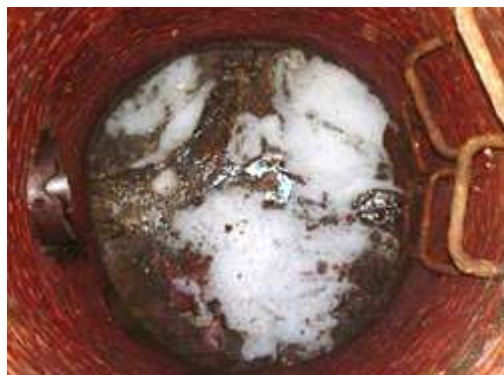
Comments **Foaming in MH from upstream Beauty salon. - This MH has been visited several times to try and get a Top View phot - this is as good as it gets.**

Corroded steps. Bench and Channel debris.

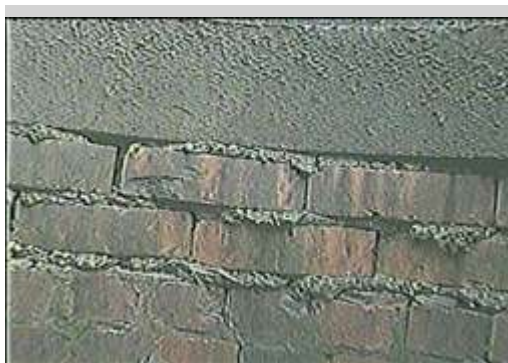
Defect

Frame leaks. Adjustment deterioration, loose brick and infiltration.

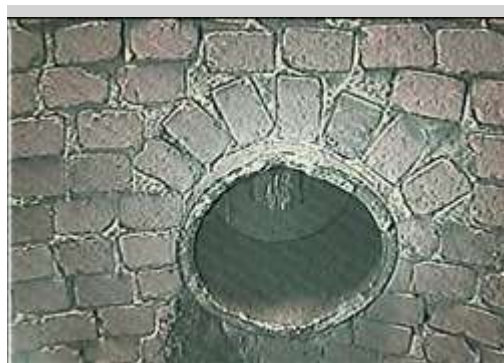
Defect

Barrel deterioration and infiltration.

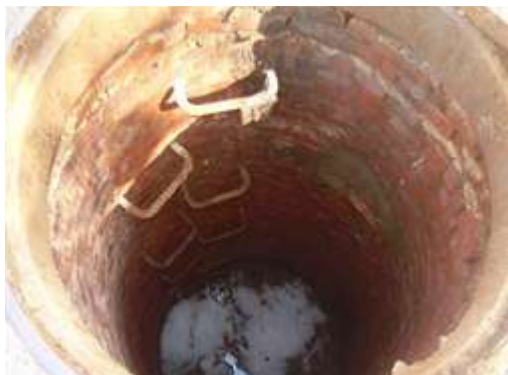
Defect

Frame leaks. Adjustment deterioration, loose brick and infiltration. Corbel and Barrel infiltration.

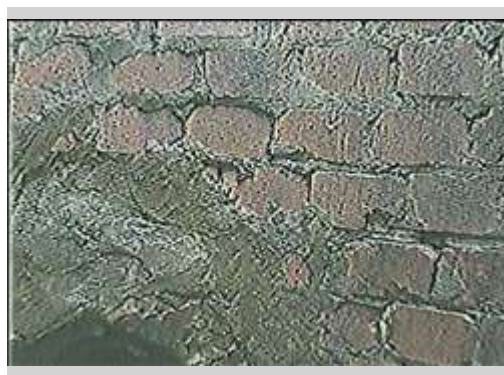
Defect

Barrel deterioration and infiltration.

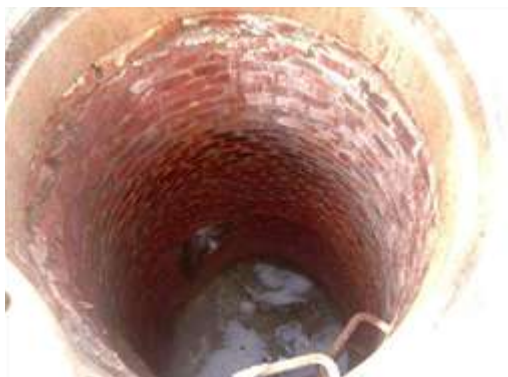
### Defect

Frame leaks. Adjustment deterioration, loose brick and infiltration. Corbel and Barrel infiltration - other side.

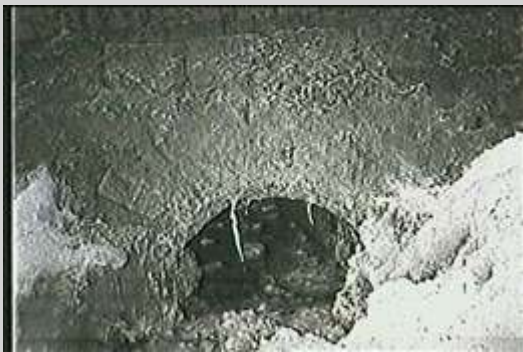
### 10 in. Circular Gravity Sewer Pipe Out @ 12 O'Clock

Deposits: ☐ None ☒ Mud ☐ Sludge ☒ Debris ☒ Grease

Silt Depth: **3** (in.) Deposits Extent: **Medium**

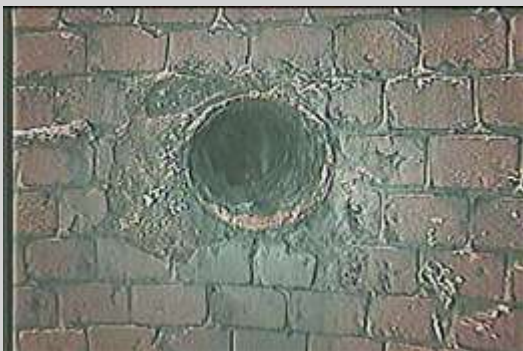
### 8 in. Circular Gravity Sewer Pipe In @ 3 O'Clock

Infiltration: **Evidence** Pipe Seal Cond: **Broken**

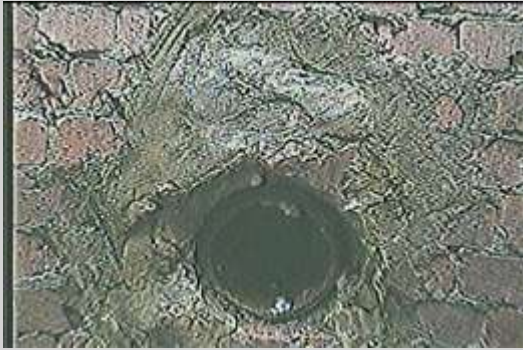
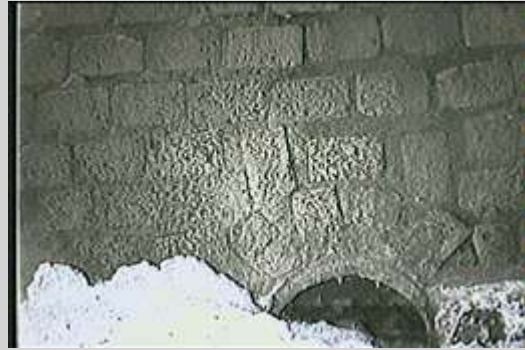
Pipe In @ 6 O'Clock

Infiltration: **Evidence** Pipe Seal Cond: **Cracked**

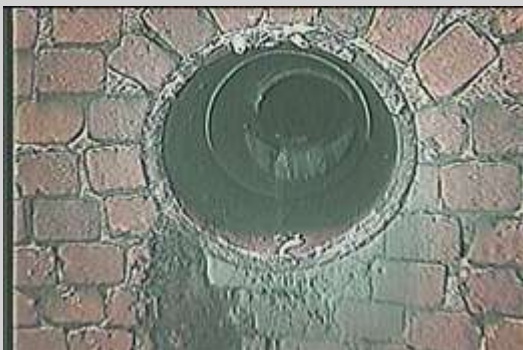
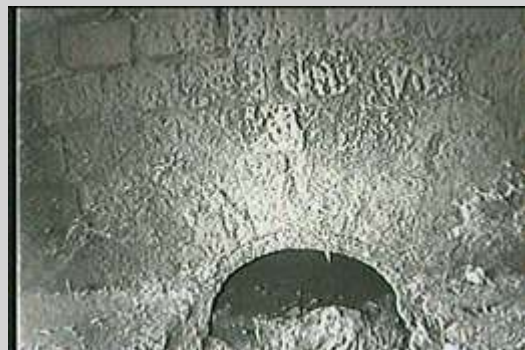
Pipe In @ 9 O'Clock

Deposits: ☐ None ☐ Mud ☐ Sludge ☒ Debris ☒ Grease

Silt Depth: **5** (in.) Deposits Extent: **Heavy**

Infiltration: **Evidence** Pipe Seal Cond: **Unknown**
